Manhole Inspection Summary

Manhole # S13A1_005MH

Insp Date: **3/27/08 9:13 AM**

Location Address: **3012 Highman ave**

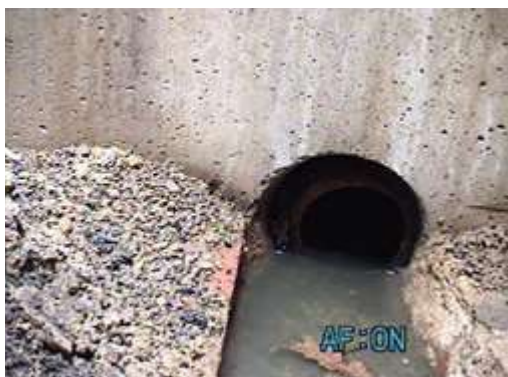
Defect 5

Condition: ☐ Sound ☐ Cracked ☐ Root Intrusion ☐ Deteriorated ☐ Leaks ☒ **Debris**

channel cond debris

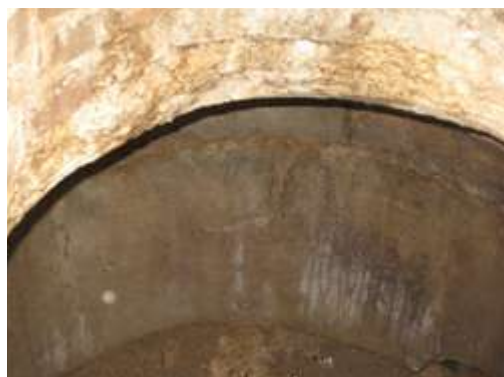
Defect 4

Infiltration: ☐ None ☐ Joint ☐ Cracks ☐ Mortar ☐ Roots ☒ **Wall**

chimney infiltration

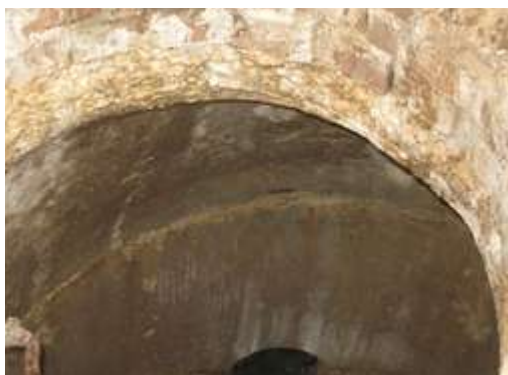
Defect 3

Infiltration: ☐ None ☐ Joint ☐ Cracks ☐ Mortar ☐ Roots ☒ **Wall**

Barrel infiltration

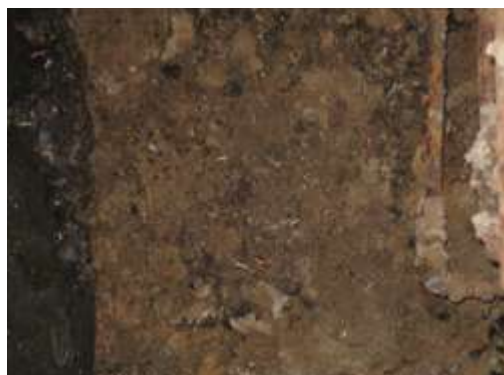
Defect 2

Condition: ☐ Sound ☐ Cracked ☐ Root Intrusion ☐ Deteriorated ☐ Leaks ☒ **Debris**

unkown diposits build up on bench.

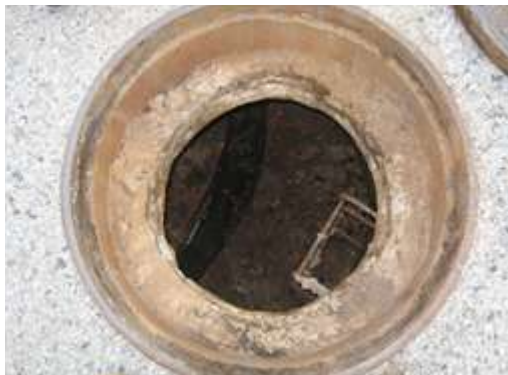
Defect 1

Offset: **3** (in.)

Count: **3** Missing: **0** ☒ **Corroded**

chimney offset & corroded steps

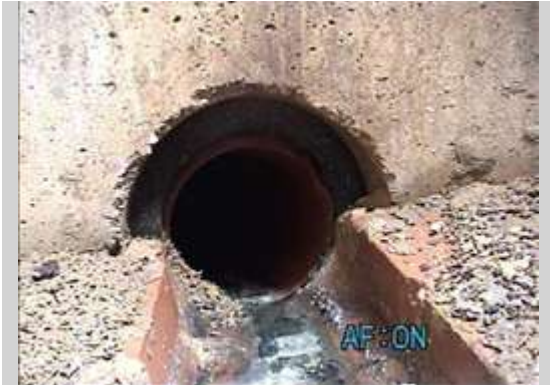
12 O'Clock Outflow

8 in. Circular Gravity Sewer
Pipe Out @ 12 O'Clock

Pipe Height: **8.4** (in.) Rod and Bar (Angled)
Pipe Material: **Clay** ☐ Pipe Lined
Invert Depth: **6.22** (ft.) Flow Characteristics: **Slow**
Deposits: ☒ None ☐ Mud ☐ Sludge ☐ Debris ☐ Grease
Silt Depth: **0** (in.) Deposits Extent:
Infiltration: **Evidence** Pipe Seal Cond: **Unknown**

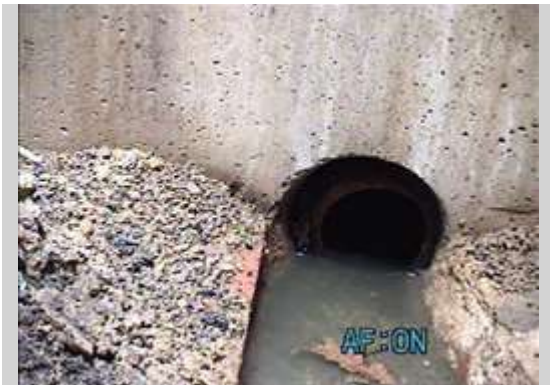
7 O'Clock Inflow

6 in. Circular Gravity Sewer
Pipe In @ 7 O'Clock

Pipe Height: **6** (in.) Rod and Bar (Angled)
Pipe Material: **Clay** ☐ Pipe Lined
Invert Depth: **6.20** (ft.) Flow Characteristics: **Slow**
Deposits: ☒ None ☐ Mud ☐ Sludge ☐ Debris ☐ Grease
Silt Depth: **0** (in.) Deposits Extent:
Infiltration: **Evidence** Pipe Seal Cond: **Unknown**
